# Tidal Freshwater Rappahannock River Total Maximum Daily Load Study

Technical Advisory Committee Meeting  
Fredericksburg, Virginia  
June 5, 2007

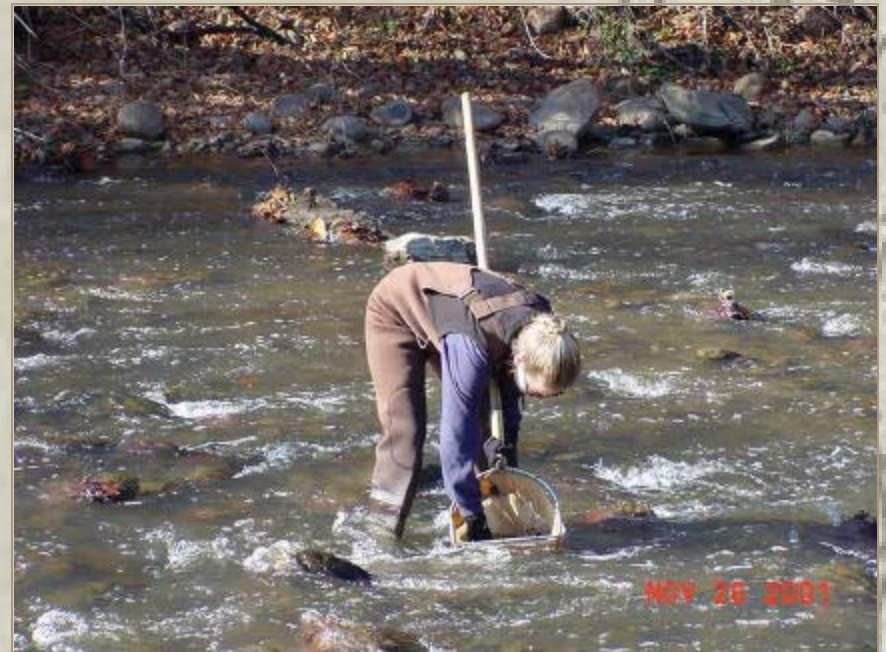
- Perform physical and chemical monitoring on water bodies throughout the state.
- Monitor parameters such as:
  - pH
  - Temperature
  - Dissolved Oxygen
  - Health of Biological Community
  - Bacteria
  - Nutrients
  - Fish Tissue
  - Metals/Toxic Pollutants
